PELICAN STATE INSPECTION, L.L.C.
Office / Cell (318) 294-1972 Fax (866) 497-4428

RE: 1234 Typical Older House Report

Report Summary

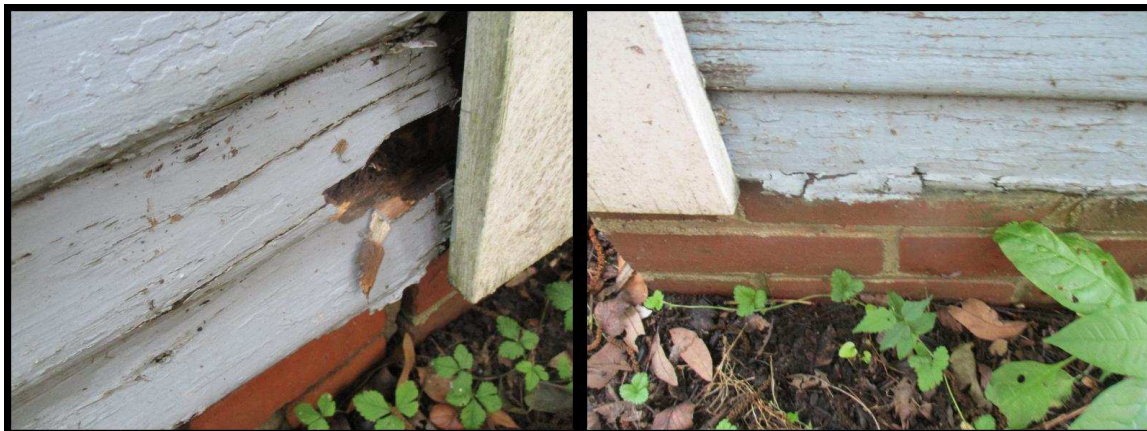
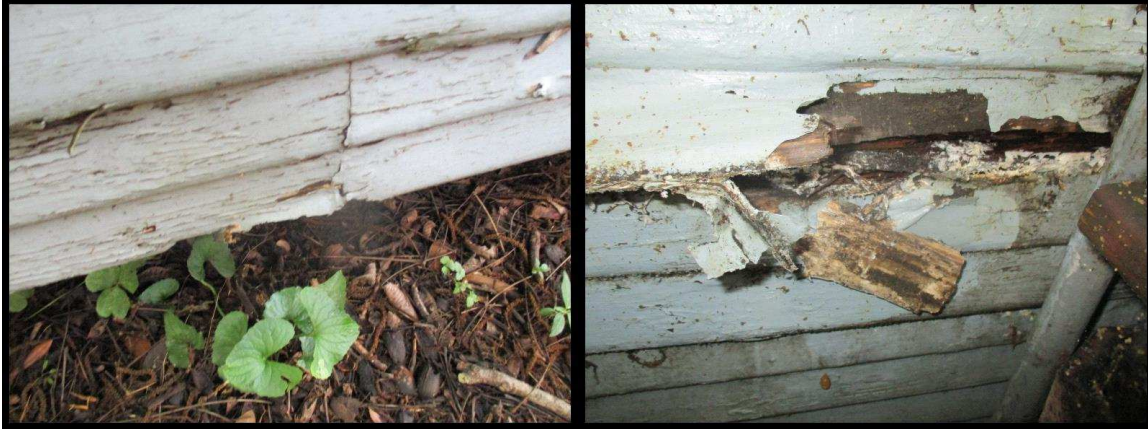
WOODEN HORIZONTAL STRIP SIDING CONDITION

There were damaged / decayed areas wooden horizontal strip siding noted. Examples pictured.

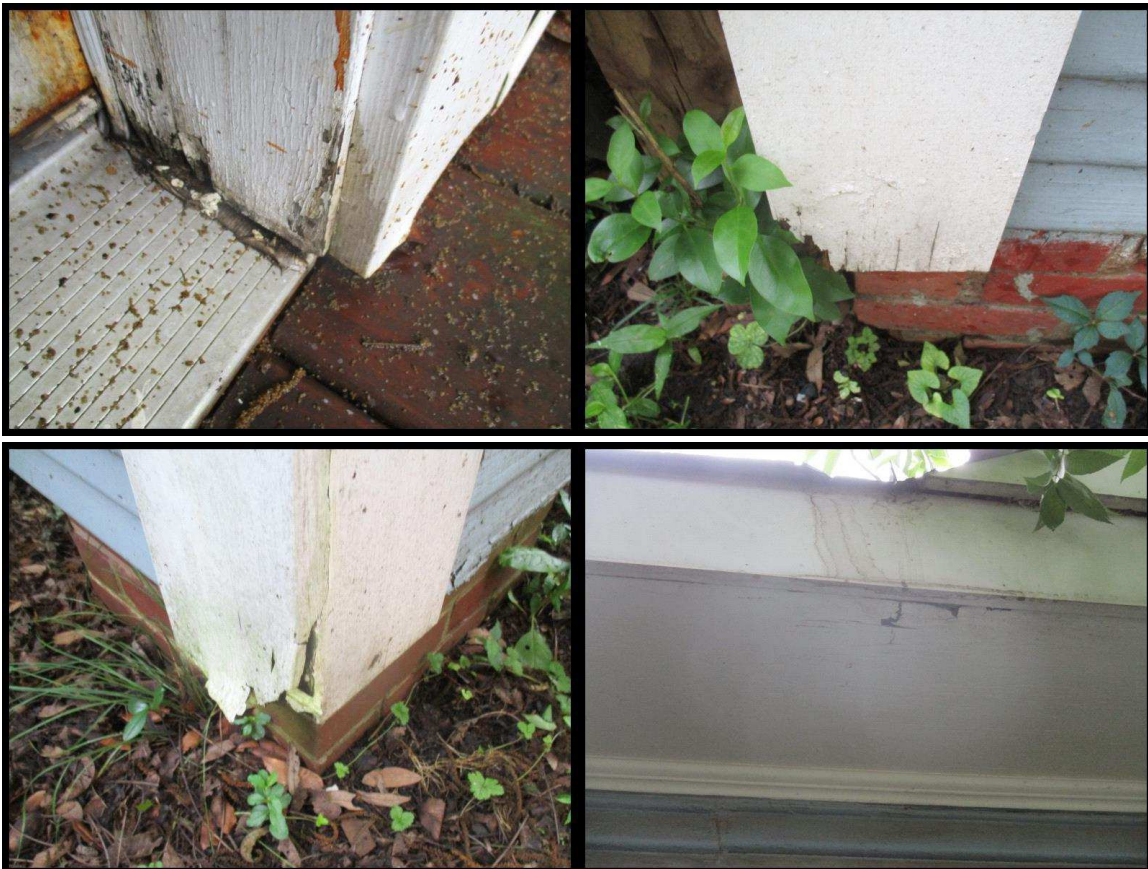
TRIM AND SOFFIT CONDITION

Damage was noted in areas of the trim and soffits. Examples pictured.

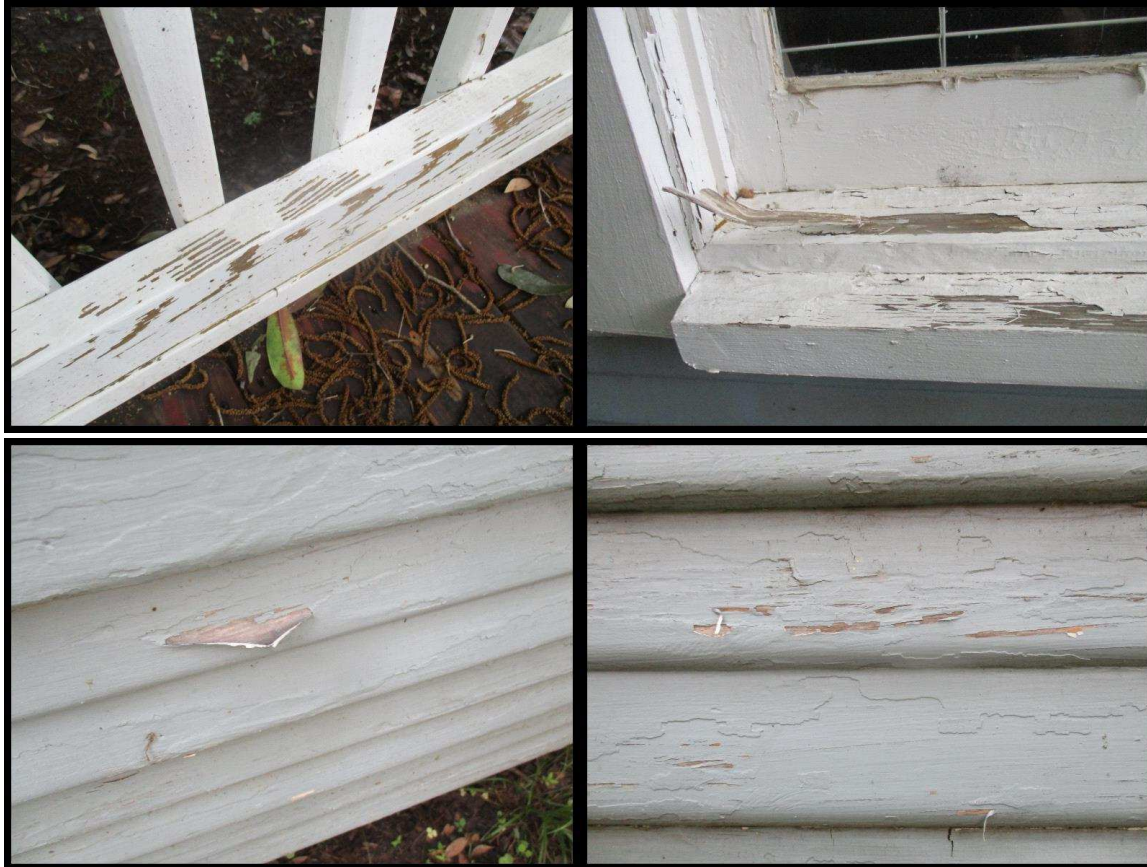
EXTERIOR PAINTED SURFACES CONDITION

Peeling paint was noted in the deck railings, trim, and wooden siding. Examples pictured.

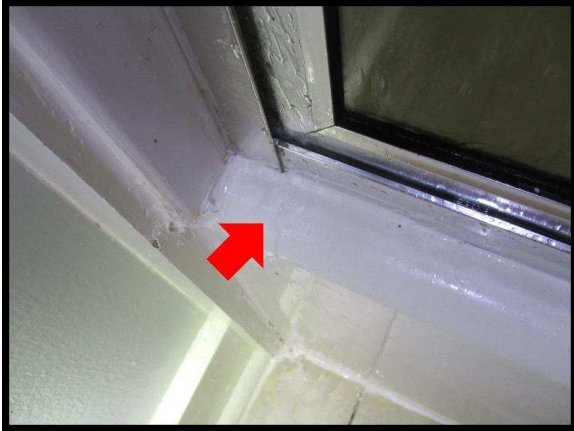
SHOWER DOOR

The master bathroom shower door leaked.

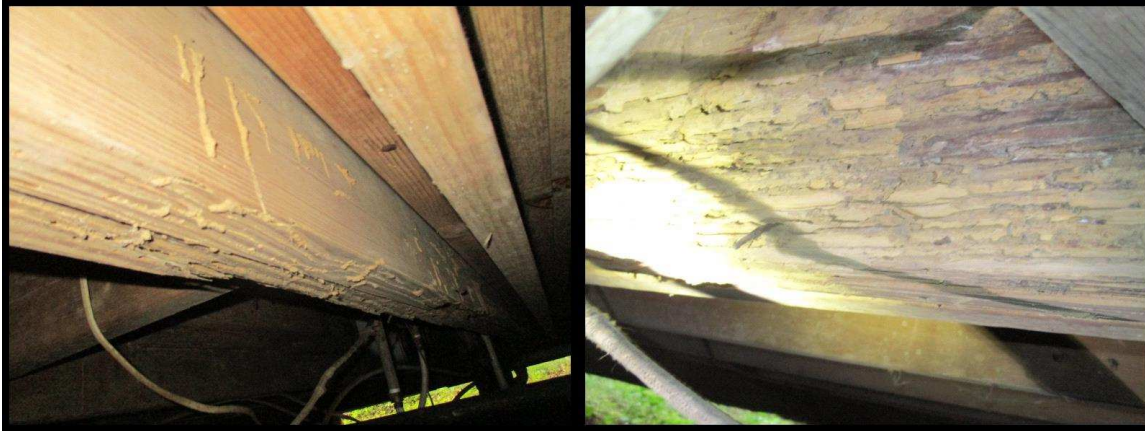
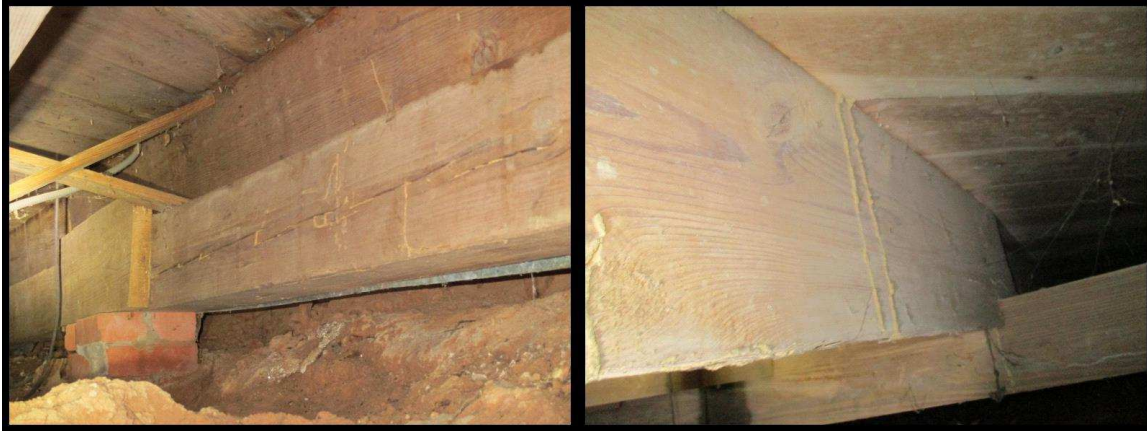
VISIBLE FRAMING CONDITION

There was wood damaging insect damage noted in sills and piers in the front of the house and under bathroom #1. Some of the damage appears to be structurally significant. Examples pictured.

Due to the current conditions it is RECOMMENDED that a licensed foundation contractor make a further evaluation of the entire foundation and repairs as needed prior to the close of escrow.

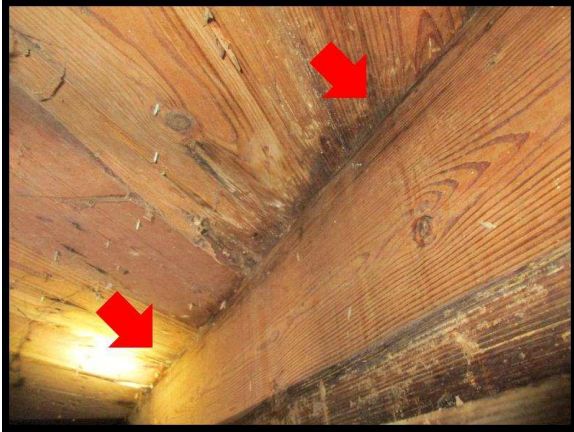
VISIBLE SUBFLOOR CONDITION

There were soft spots noted in the sub flooring in areas in the front of the front of the house from the interior and signs of damage noted from the crawlspace.

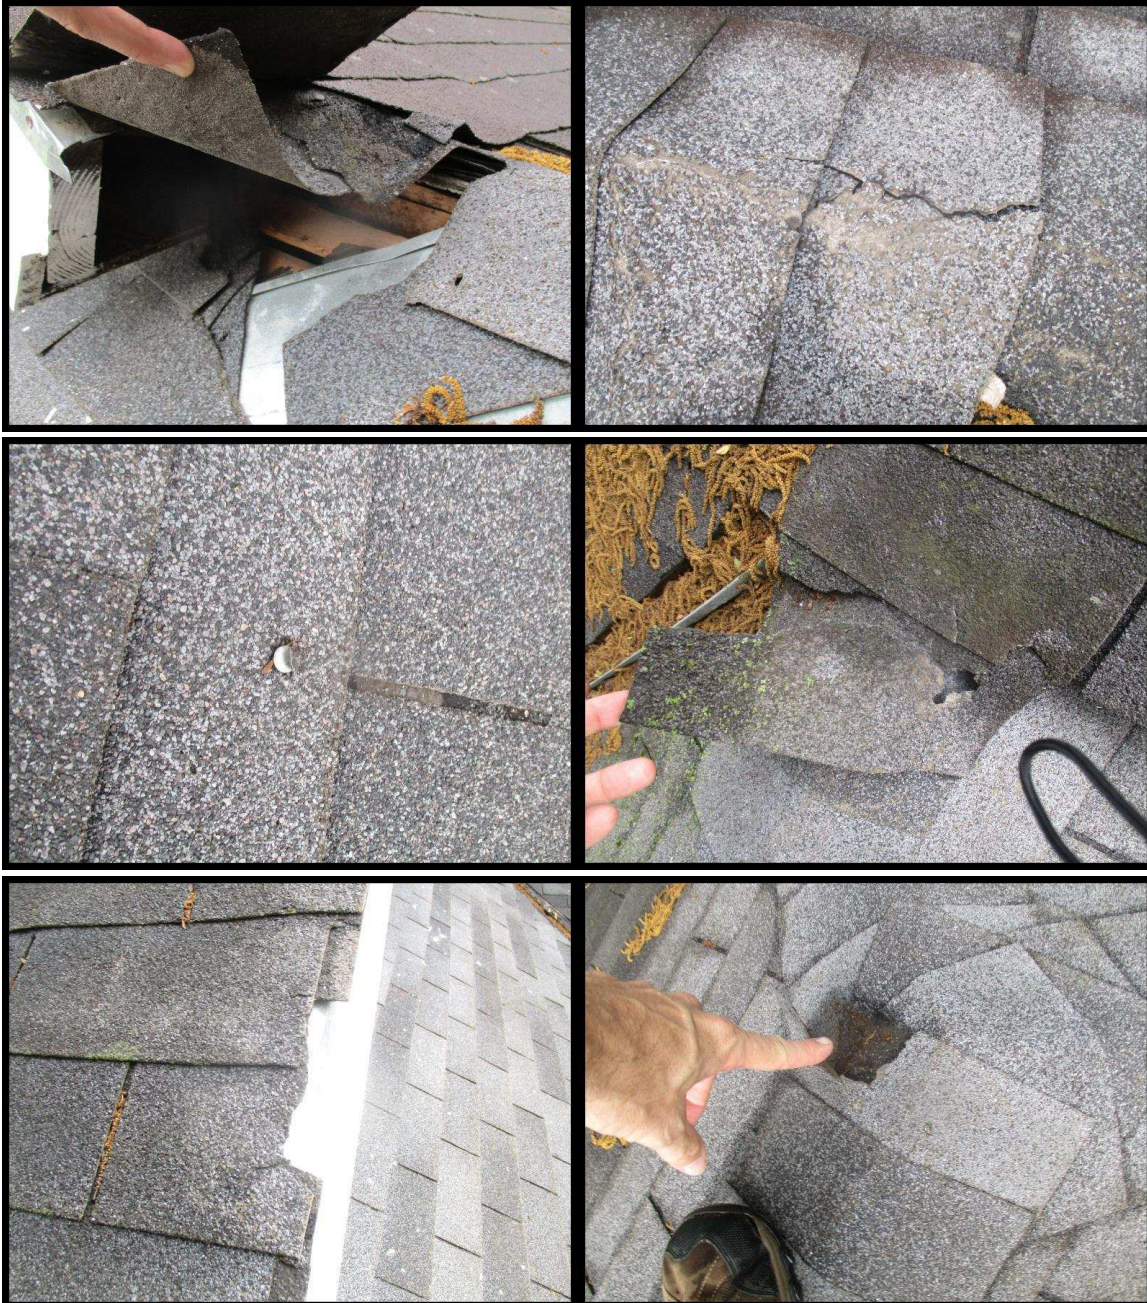
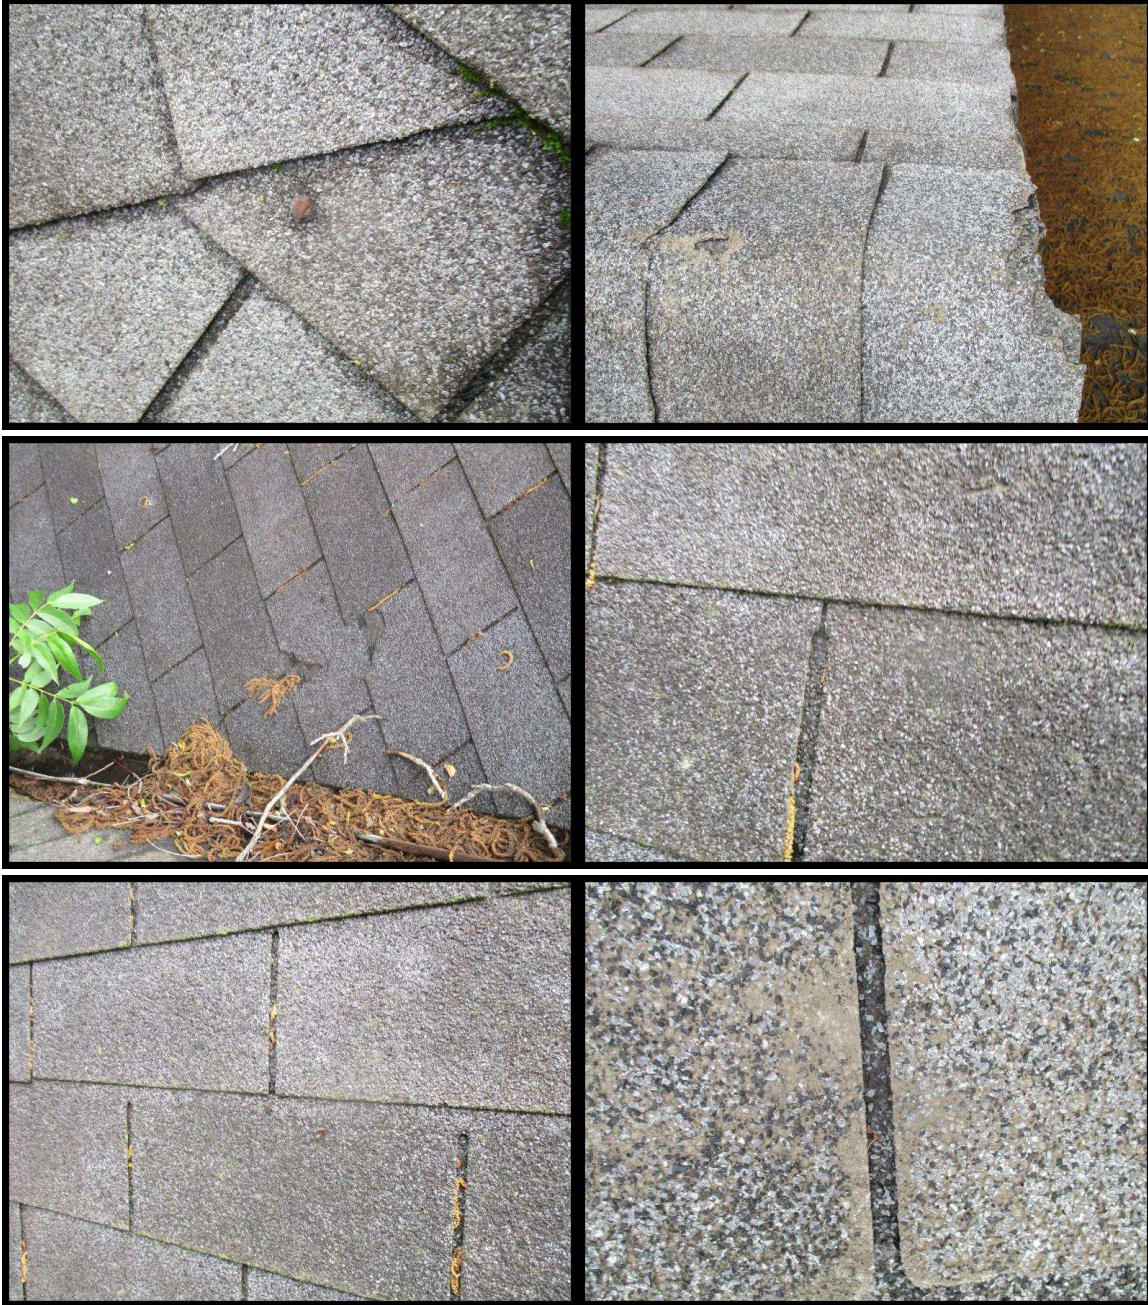
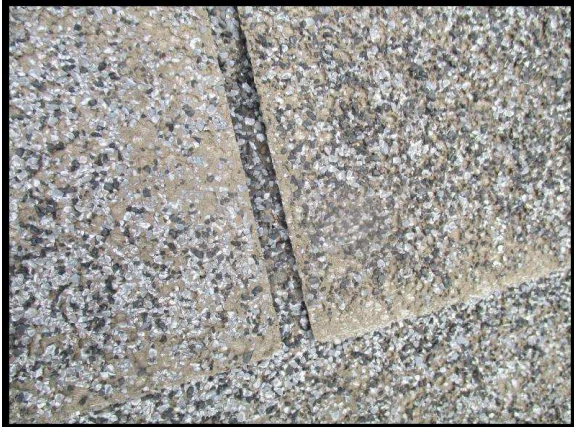
ROOFING

There were damaged shingles noted. Nail pop ups were noted on the roof. There were shingles that did not have the proper overlap noted. There were shingles with excessive granular loss noted. Examples pictured.

Due to the current conditions it is **RECOMMENDED** that a licensed roofing contractor make a further evaluation of the entire roof system and repairs as needed prior to the close of escrow.

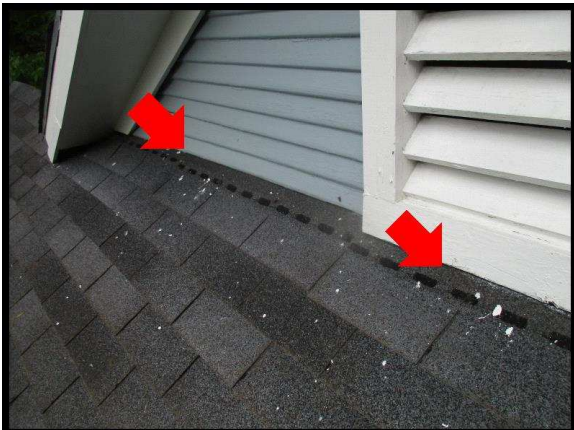
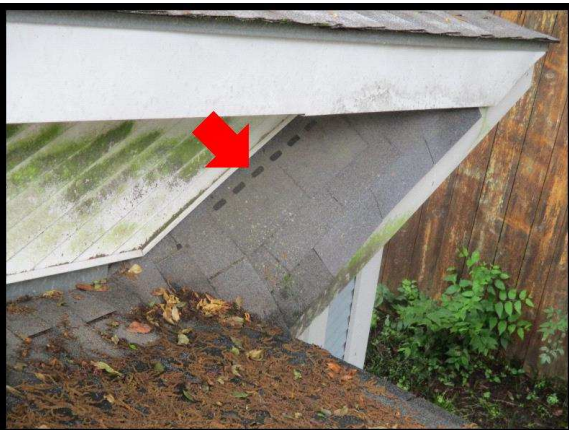
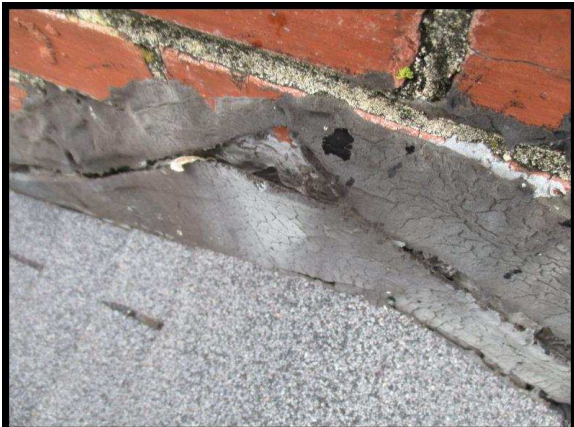
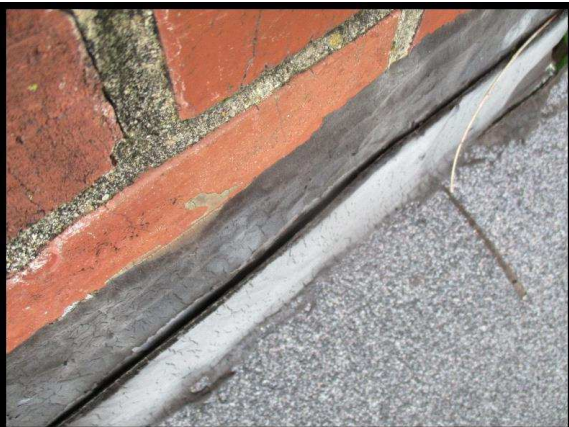
FLASHING

There was not a visible flashing in some of the front gable dormer areas. The flashing around the chimney has a large tar application that was cracking and peeling. Examples pictured.

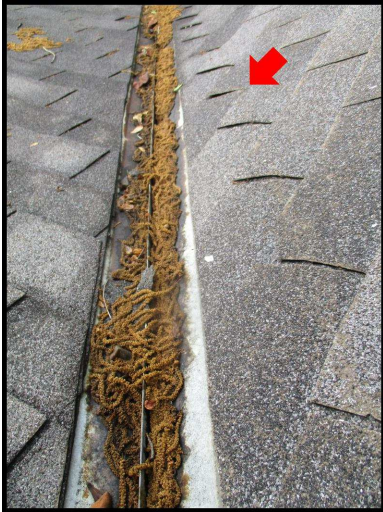
VALLEYS

One of the valleys was noted that was lifting off the roof surface.

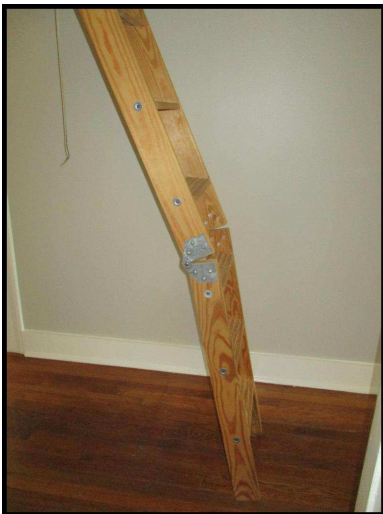
ATTIC

There was a pull down ladder installed. **The ladder was too short. Replacement is needed.**

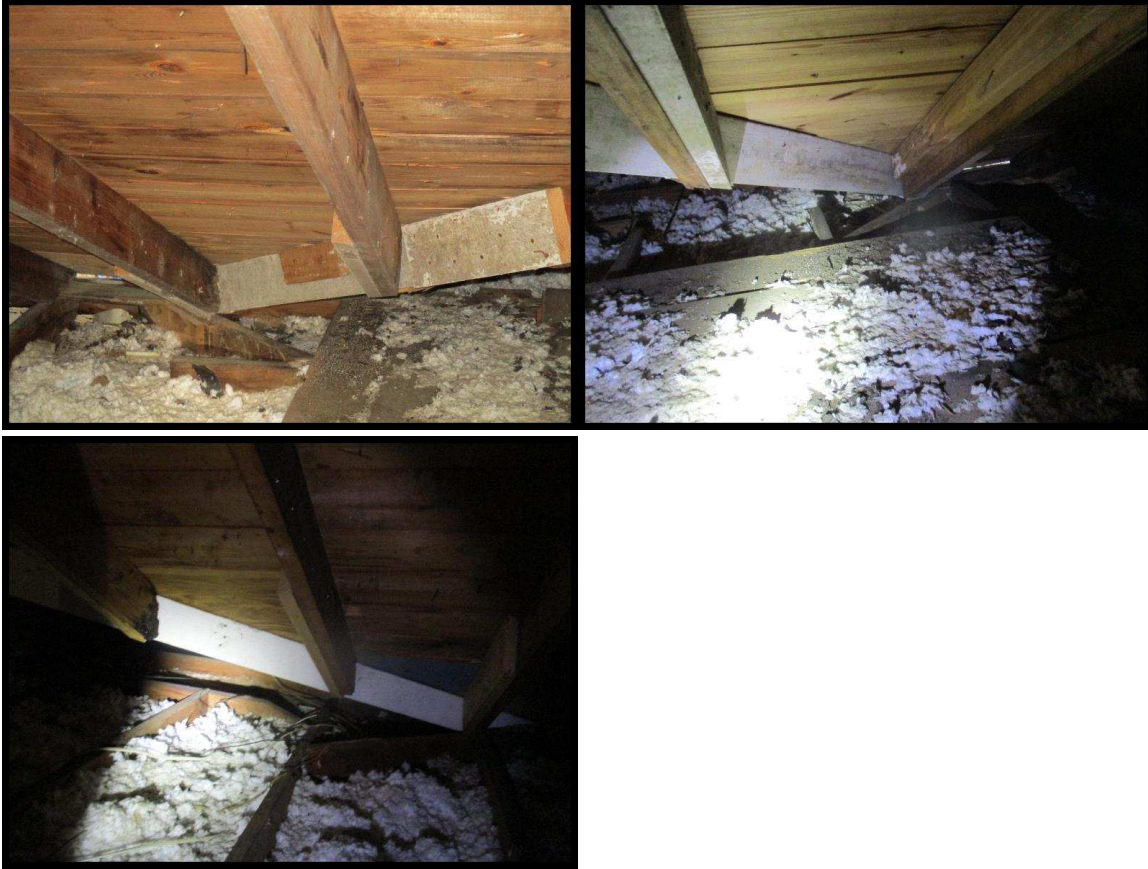
ROOF & CEILING FRAMING CONDITION

There were poorly made repairs to the framing in the front portions of the house. Examples pictured.

Due to the current conditions it is **RECOMMENDED** that a licensed framing contractor make a further evaluation of roof framing repairs and make any repairs as needed prior to the close of escrow.

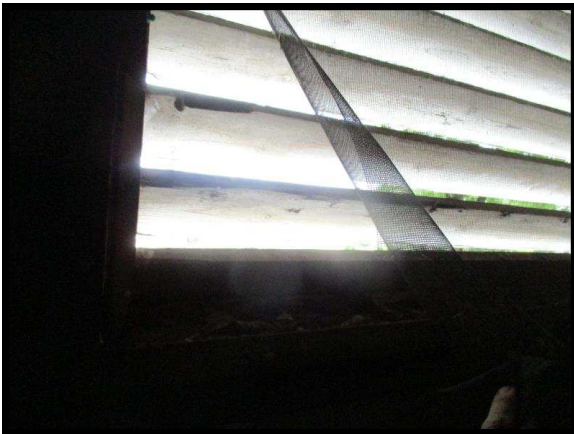
VENTILATION HI/LOW

The front gable vent screen was torn / damaged.

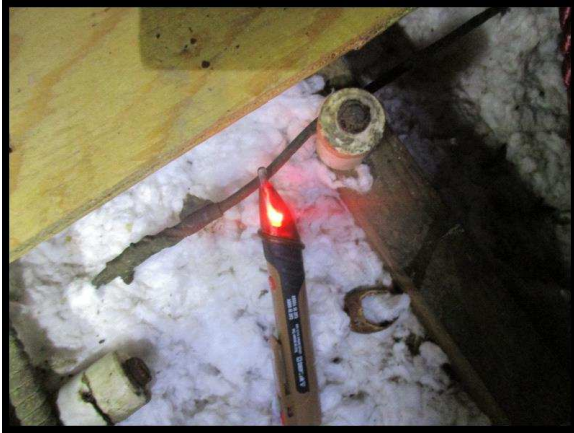
FEEDER AND CIRCUIT WIRING

The house has existing knob and tube wiring in use. Due to the age of the wiring some insurance companies will no longer write policies on homes with knob & tube wiring.

It is recommended that you inquire with you insurance company to be sure they will insure the property. There was also BX cable, cloth braided romex, and some modern grounded copper romex noted.

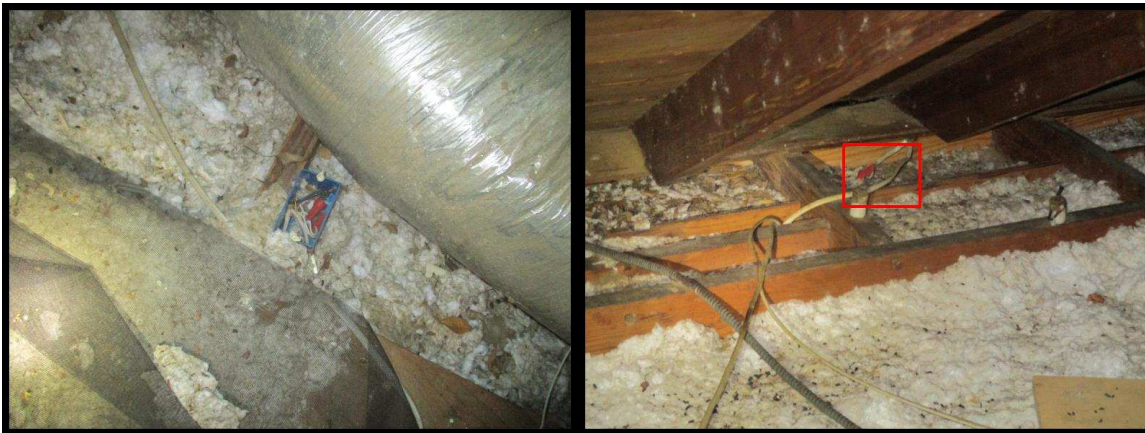
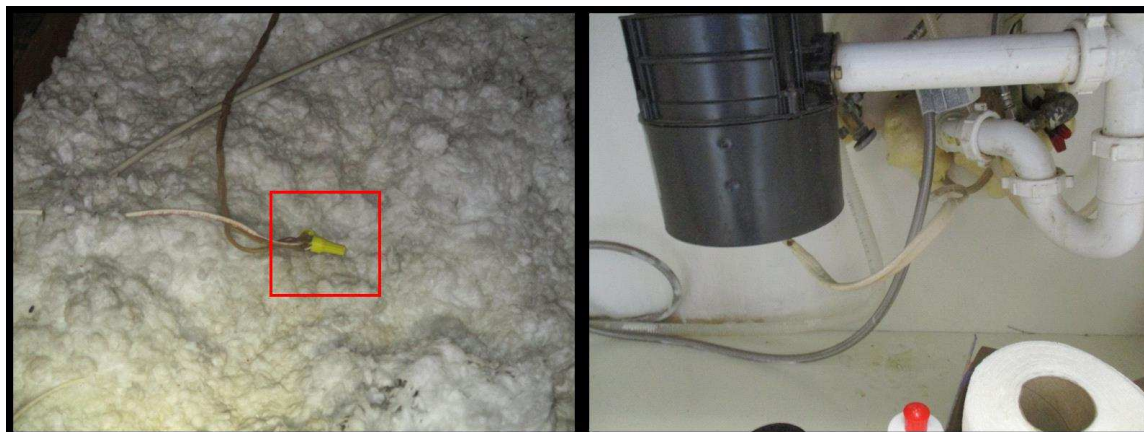
CIRCUIT WIRING CONDITION

There was knob and tub wiring noted that was buried in insulation. There were wire terminations & splices noted not in covered junction boxes. There was a junction box noted with a missing cover. The wiring for the kitchen disposal was not in conduit. Examples pictured.

Due to the current conditions it is RECOMMENDED that a licensed electrician make a further evaluation of the entire electrical system and repairs as needed prior to the close of escrow.

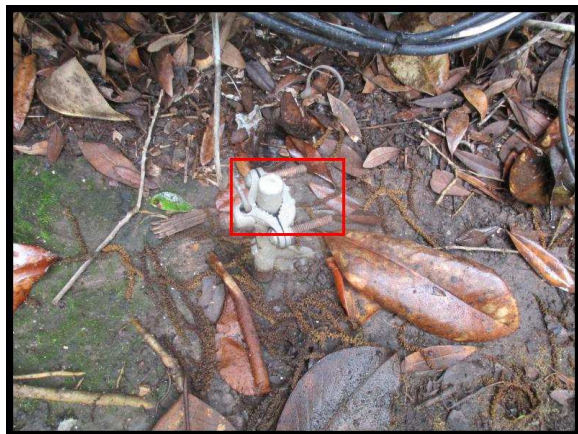
GROUNDING AND BONDING

The ground driven rod, solid conductor, and connection were located. **The clamp that attaches the ground wire to the ground rod was loose. It is located below the electrical meter.**

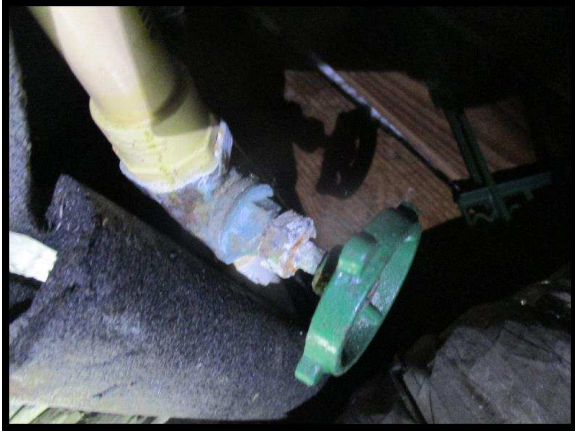
WATER HEATER FILL

There was incrustation and/or mineral deposits from a past leak on the water shut off valve. However, no leaks are visible. Small leaks such as this often seal themselves due to corrosion. This area may leak again in the

future. It is suggested that it be corrected.

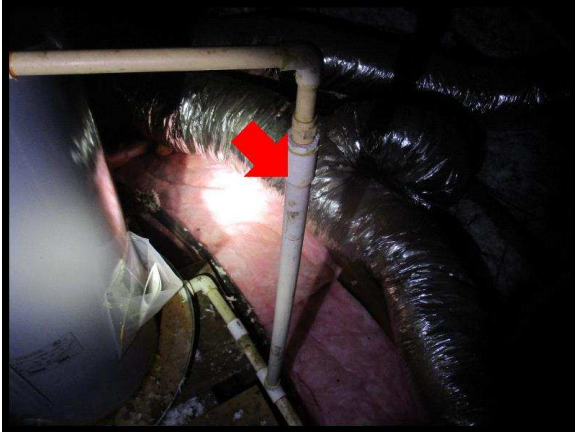
The T&P valve drain line was connected in to the PVC pan drain line.

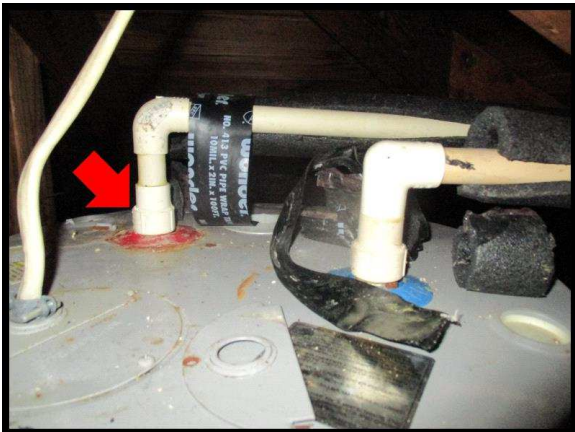
INTERIOR WATER SUPPLY PIPING CONDITION

There was PVC piping / fittings noted carrying hot water. Example pictured. Piping was noted in the crawlspace & exterior that was not insulated. PEX piping was noted in the crawlspace that was not secured / supported.

Due to the current conditions it is RECOMMENDED that a licensed plumbing contractor make a further evaluation of the entire plumbing system and repairs as needed prior to the close of escrow.

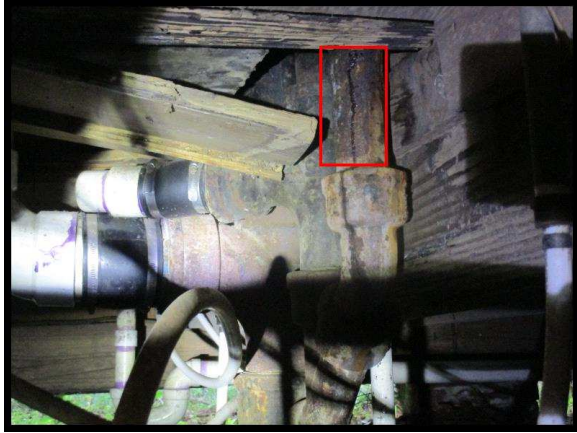
WASTE PIPING CONDITION

There was a waste piping leak noted under bathroom #1. Example pictured.

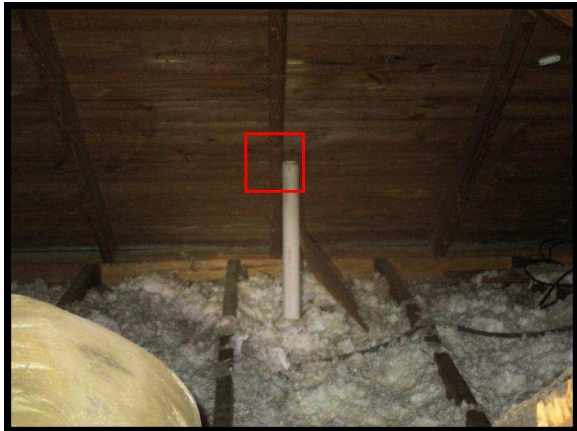
VENT PIPING CONDITION

There was a PVC vent pipe noted that terminated in the rear attic area.

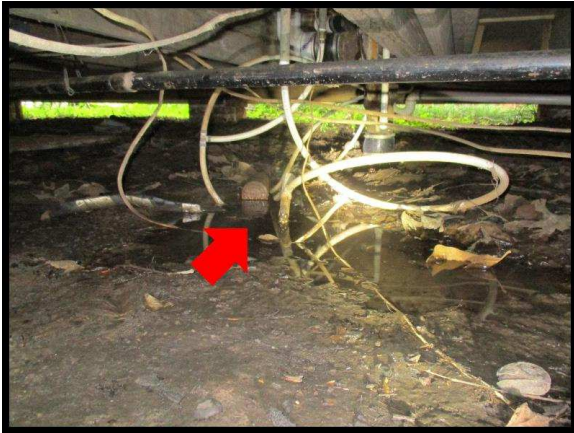
OTHER COMMENTS

There was a pool of water noted in the crawlspace around an area of supply piping and water piping. The water was moving within itself. It is possible the water could be from a supply / waste pipe leak.

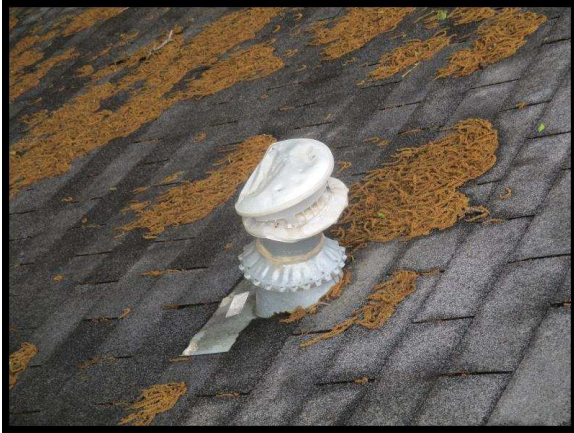
HEATING UNIT

The heating unit flue cap was crushed / damaged.

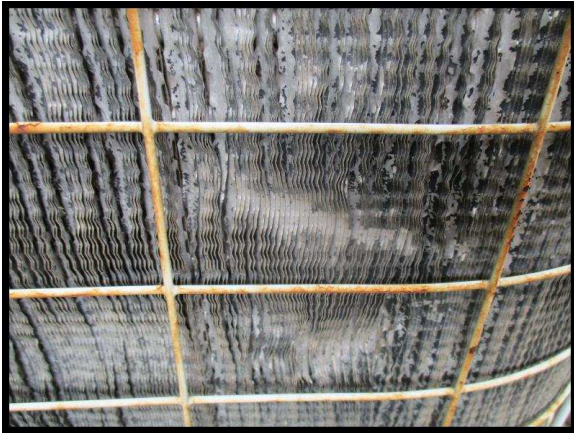
AIR CONDITIONING UNIT

The condensing coil has several damaged / crushed fins.

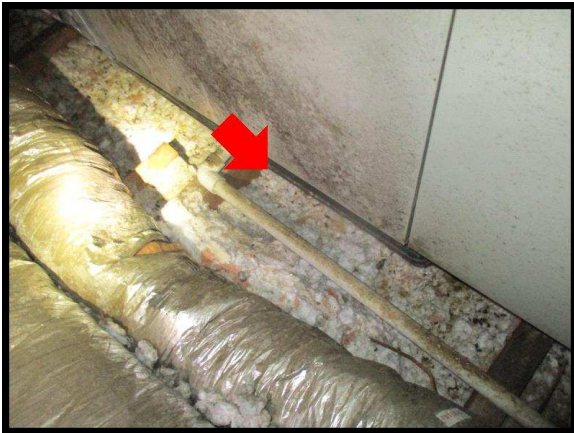
The drain pan was not properly centered under the evaporator.

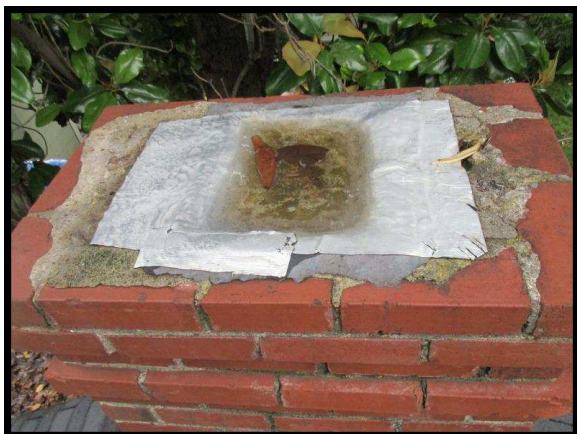
FIREPLACE

The flue was capped at the top it what appeared to be foil tape. Installation of a metal sap is recommended.

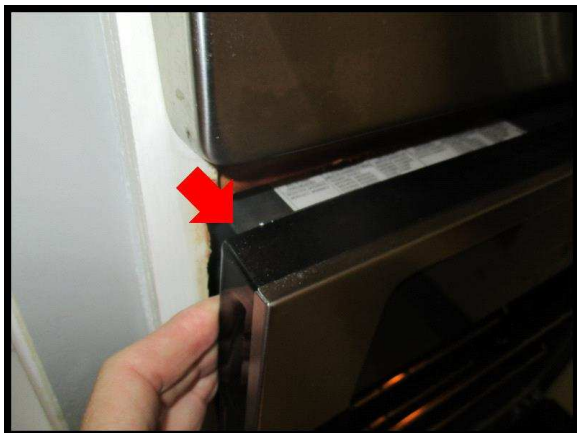
RANGE/OVEN

The oven was not secured in the cabinet.

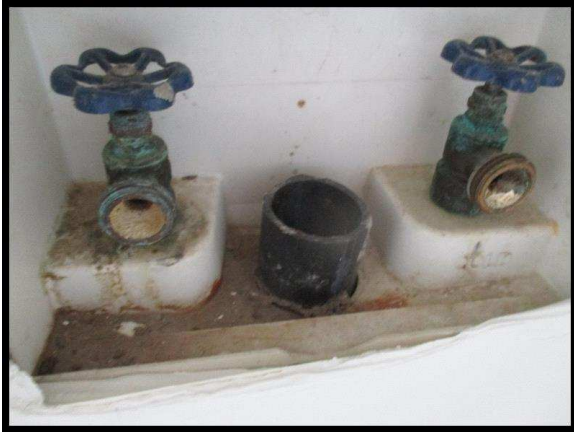
WASHER HOOKUP

There was a connection box installed in the wall supply connections and a drain pipe. The drain pipe and connections were not tested. **There was incrustation and/or mineral deposits from a past leak on the water shut off valves for the washing machine.** No leaks were visible. Small leaks such as this often seal themselves

due to corrosion. This area may leak again in the future. It is suggested that it be corrected.

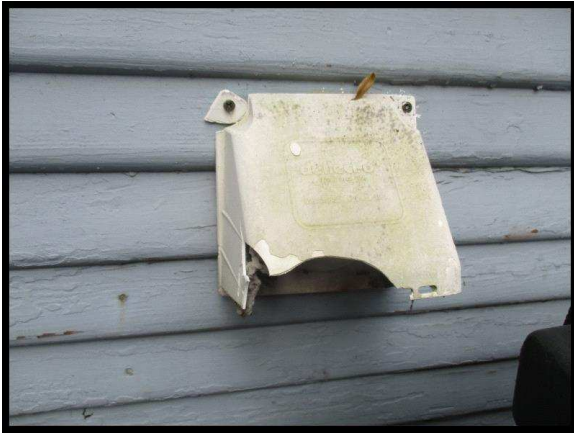
DRYER VENTILATION

The dryer vent was damaged at the exterior.
