Home Inspection Report

PELICAN STATE INSPECTION, L.L.C.

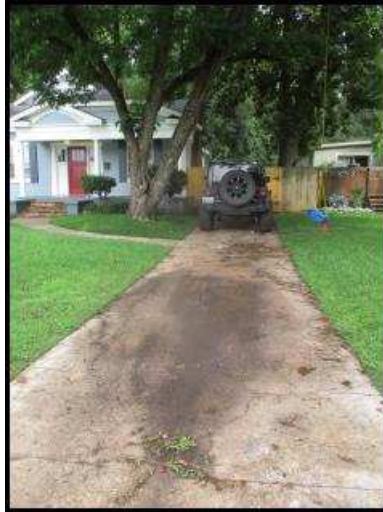
DRIVEWAY

Large cracks were noted in the driveway. Water appears to stand on the driveway when it rains. There was settling / heaving noted in the driveway. Due to the settling / heaving a trip hazard was present.

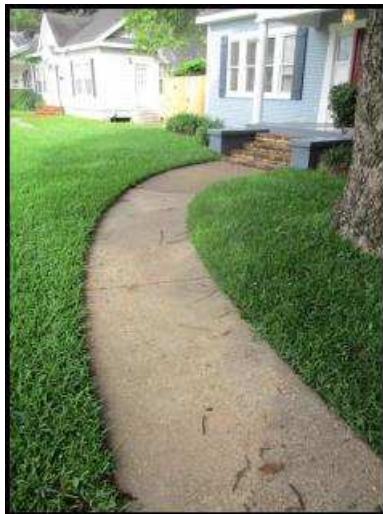
SIDEWALK

Cracking was noted.

There was a tree planted close to driveway. There was a tree planted close to sidewalk. The trees were causing damage to both the sidewalk and driveway.

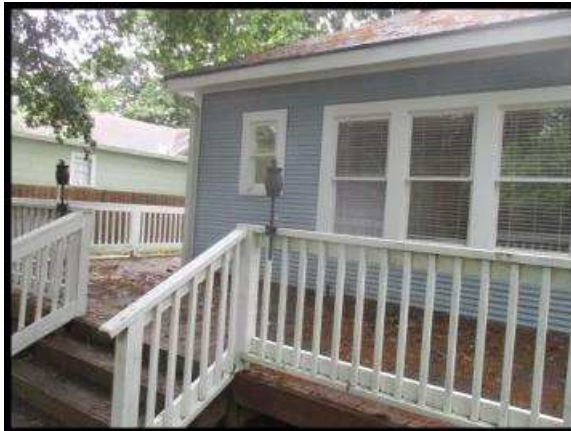
DECK

There was a hole in a section of the decking. The deck materials finished surface was worn / aged. Examples pictured.

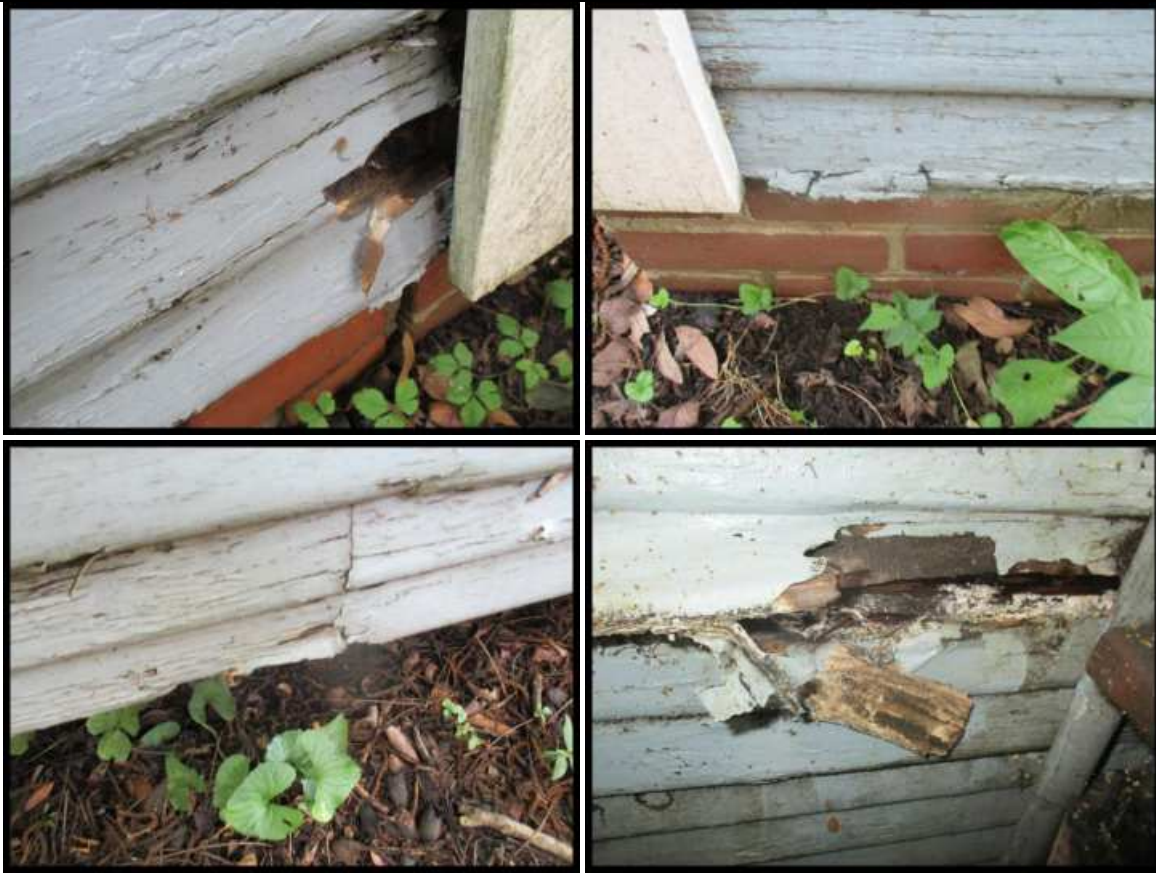
There were damaged / decayed areas wooden horizontal strip siding noted. Examples pictured.

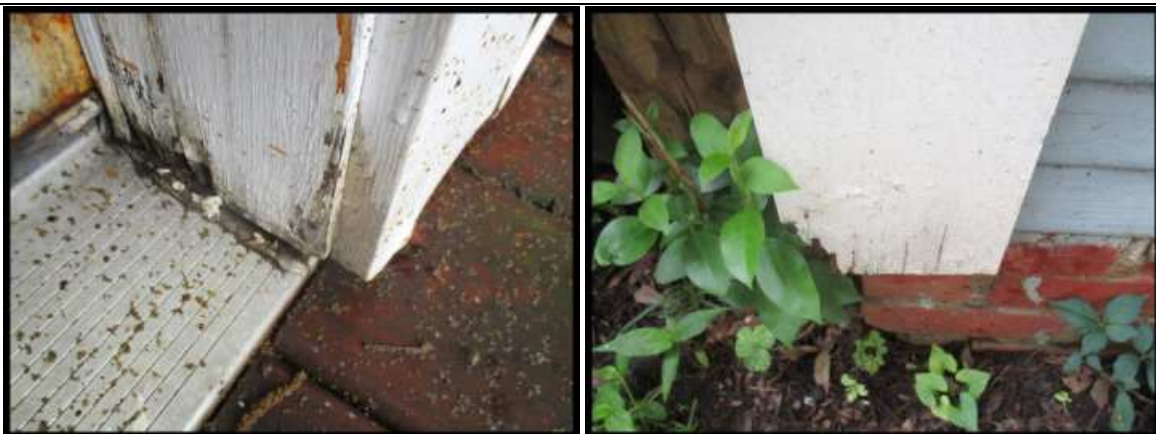
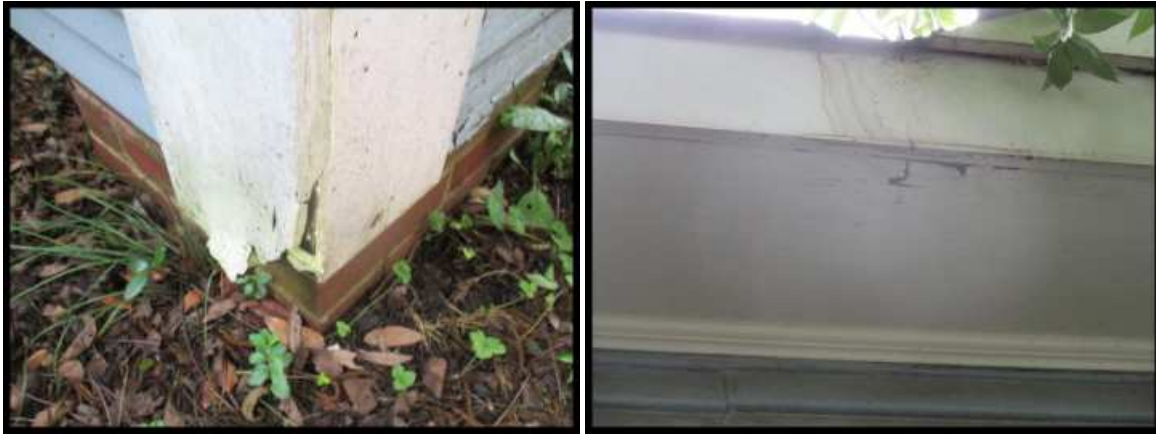
TRIM AND SOFFIT CONDITION Damage was noted in areas of the trim and soffits. Examples pictured.

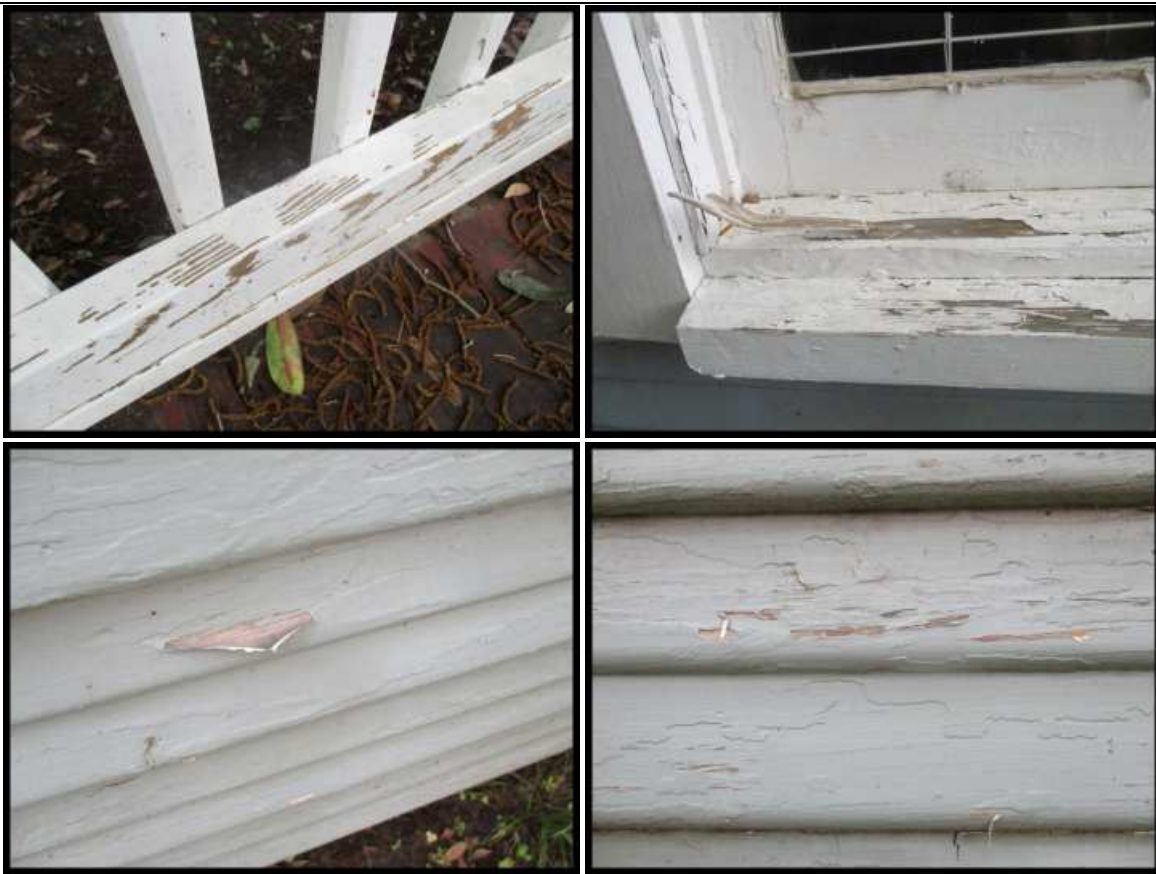
EXTERIOR PAINTED SURFACES Peeling paint was noted in the deck railings, trim, and wooden siding. Examples pictured.
CONDITION

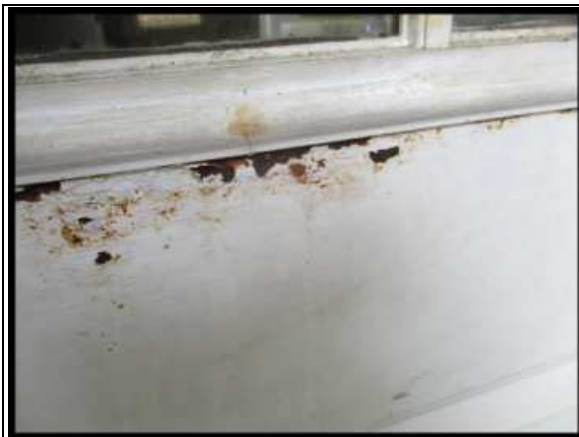
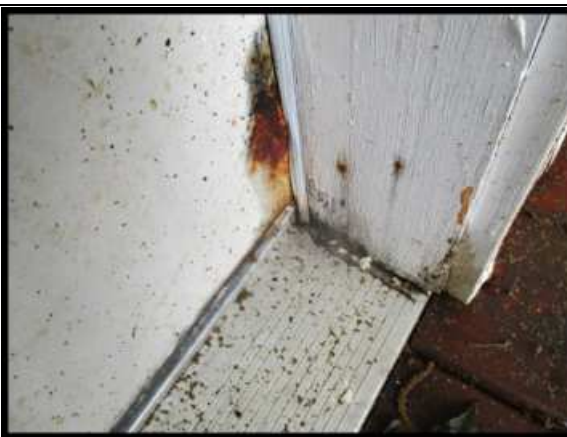
The front entry door weather stripping needed attention. Rusting / damage was noted in the side entry door. Example pictured.

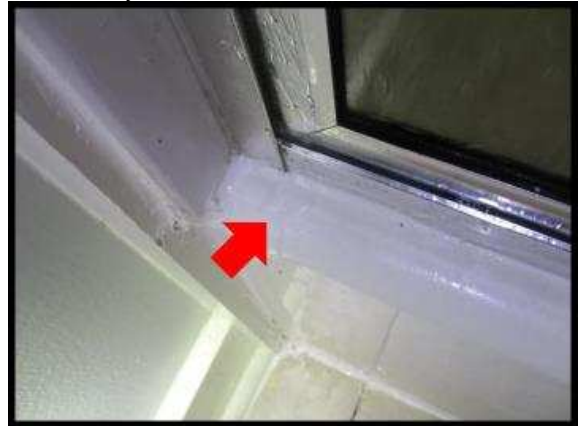
The master bathroom shower door leaked.

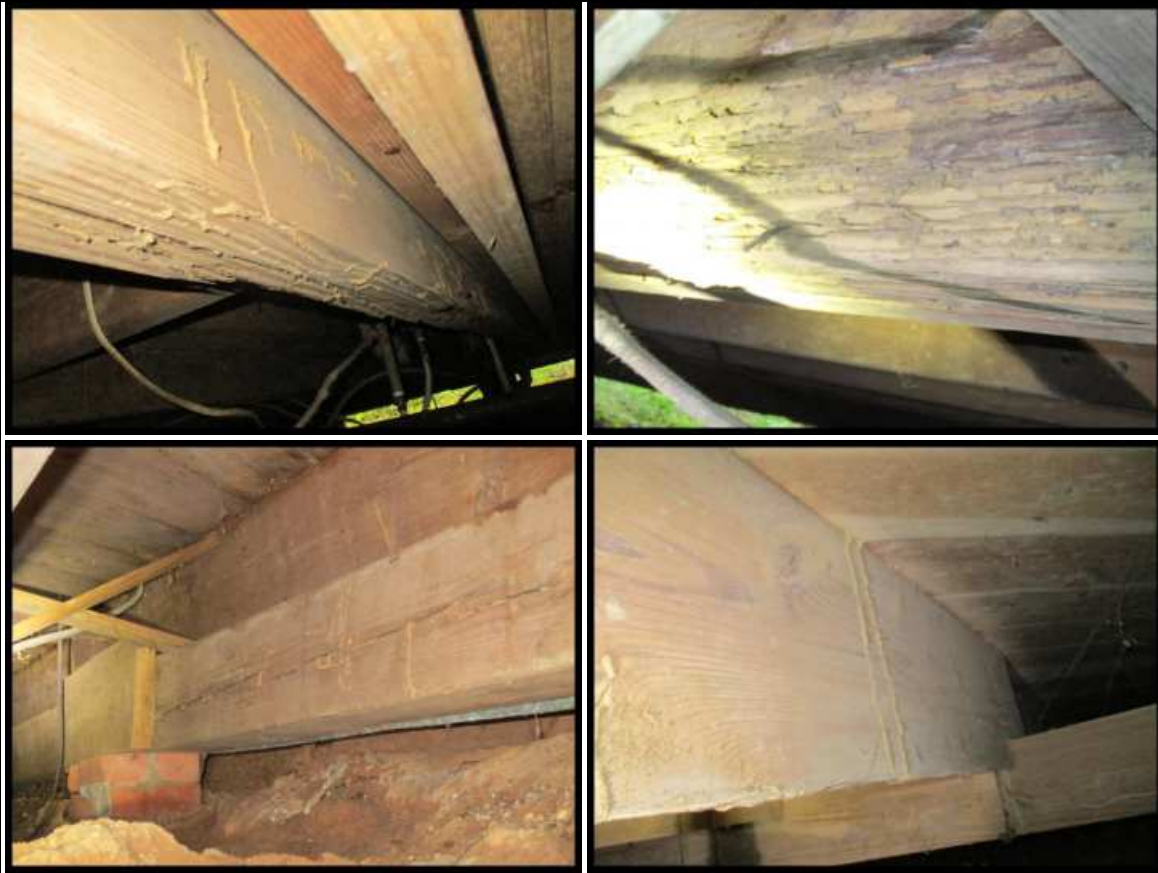
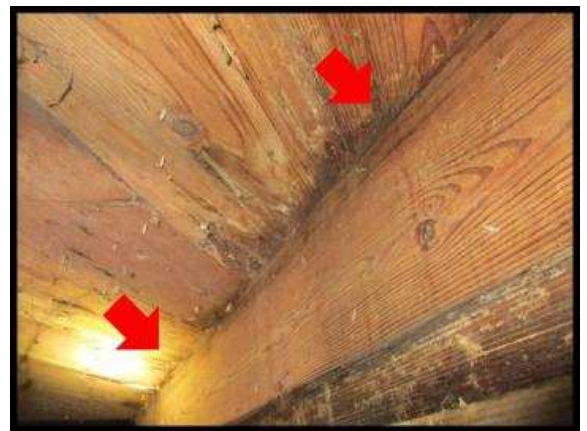
VISIBLE SUBFLOOR CONDITION There were soft spots noted in the sub flooring in areas in the front of the house from the interior and signs of damage noted from the crawlspace.

Due to the current conditions it is RECOMMENDED that a licensed foundation contractor make a further evaluation of the entire foundation and repairs as needed prior to the close of escrow.

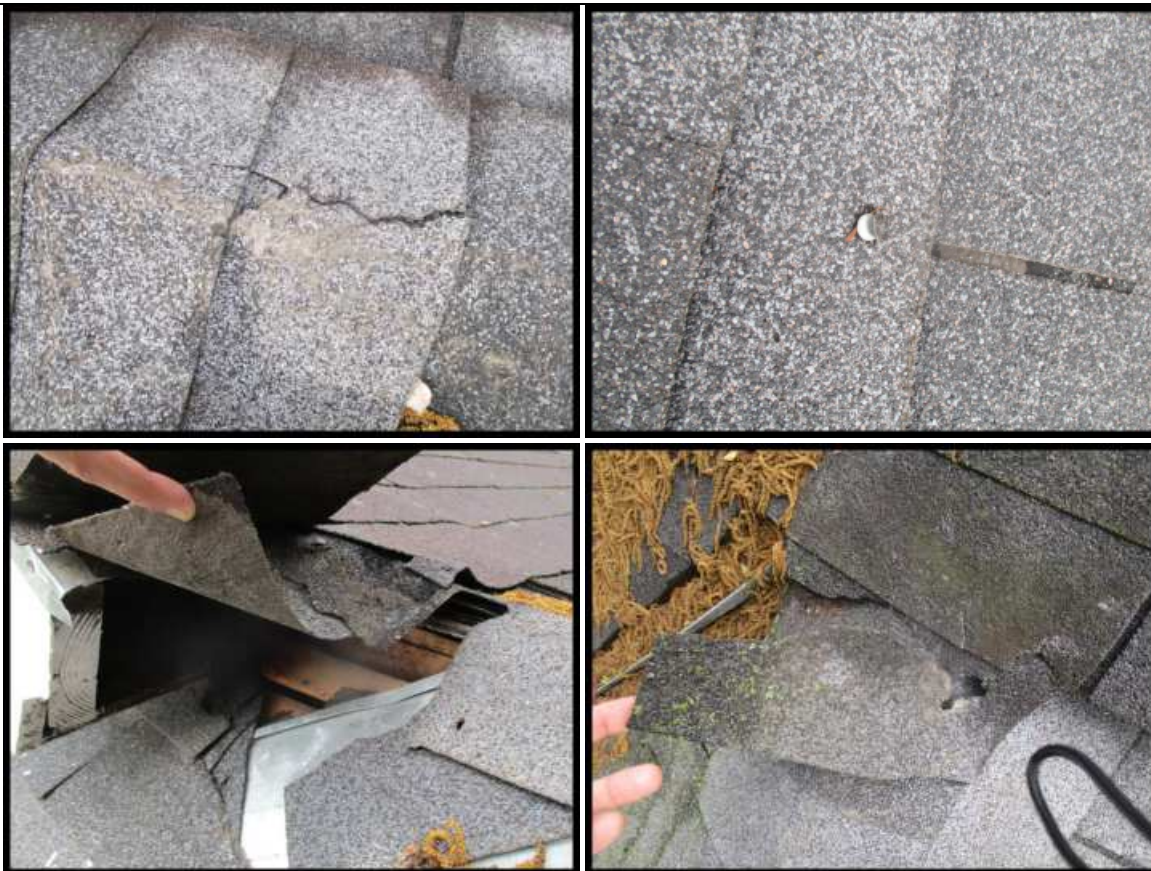
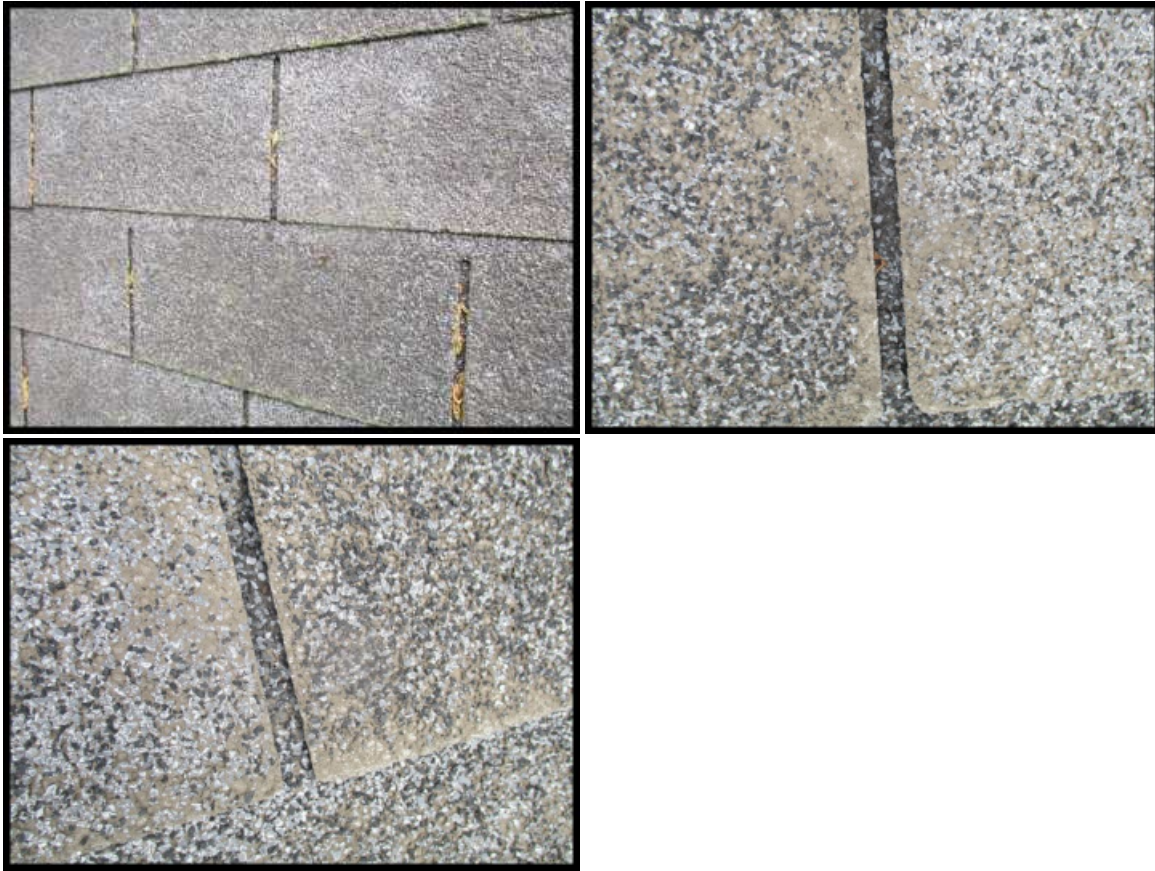
ROOF TYPE	Gables
ROOF COVERING MATERIALS	Asphalt or Fiberglass composition shingles. These consist of a cellulose or fiberglass mat and asphalt impregnated with a colored granular surface. Shingles are applied in horizontal rows.
COVER LAYERS	The roof covering on the main structure appeared to be the first covering. The number of layers was determined by counting the number of layers of shingles or material at the lower edge with consideration given the starter course.
UNDERLAYMENT NOTED	What appeared to be asphalt impregnated felt underlayment was noted under the roofing material in at least 2 locations that were checked.
CONDITION OF ROOF COVERING MATERIAL	There were damaged shingles noted. Nail pop ups were noted on the roof. There were shingles that did not have the proper overlap noted. There were shingles with excessive granular loss noted. Examples pictured.

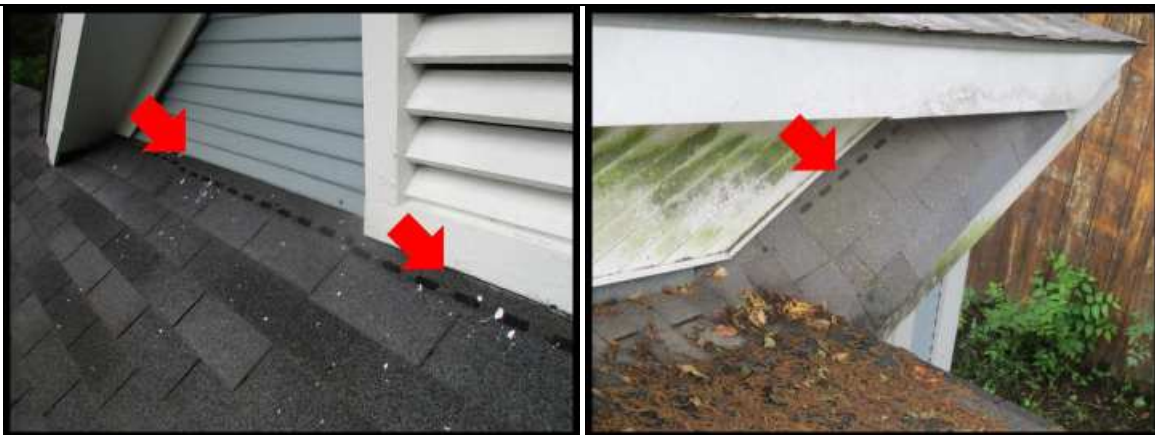
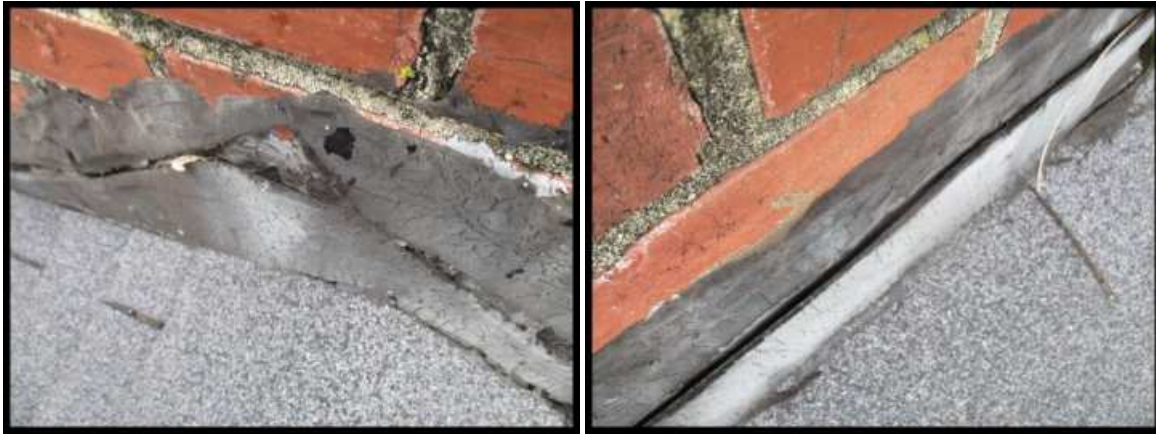
There was not a visible flashing in some of the front gable dormer areas. The flashing around the chimney has a large tar application that was cracking and peeling. Examples pictured.

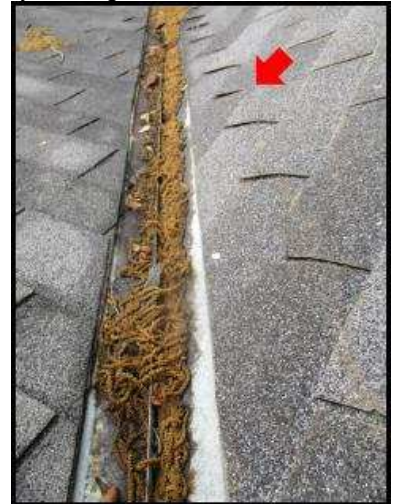
The roof covering was accessed with a ladder and inspected by walking on the roof.
One of the valleys was noted that was lifting off the roof surface.

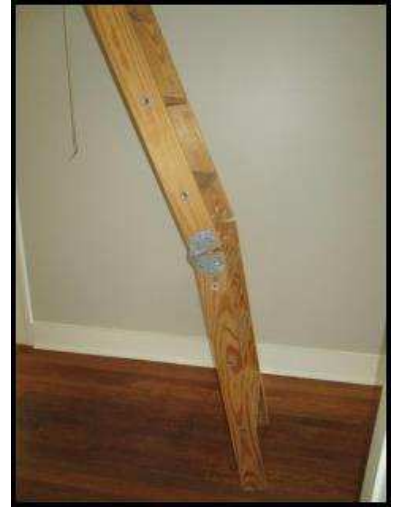
There was a pull down ladder installed. **The ladder was too short. Replacement is needed.**

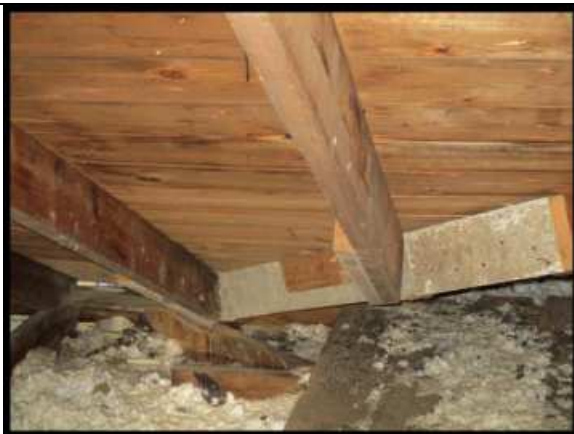
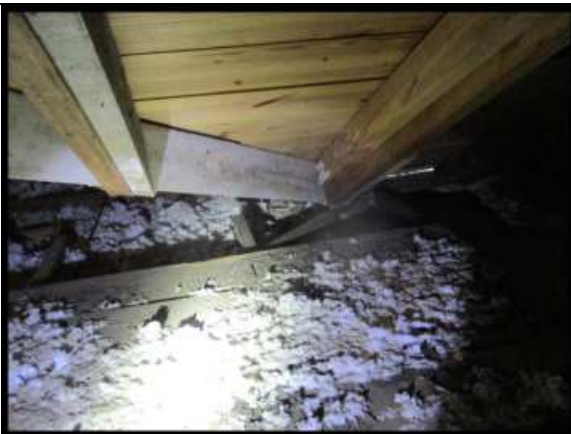
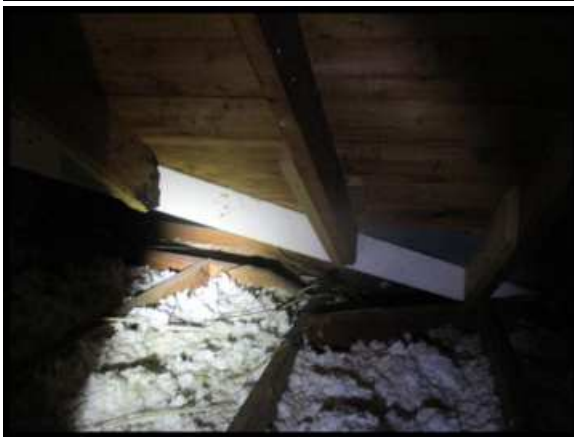
There were poorly made repairs to the framing in the front portions of the house. Examples pictured.

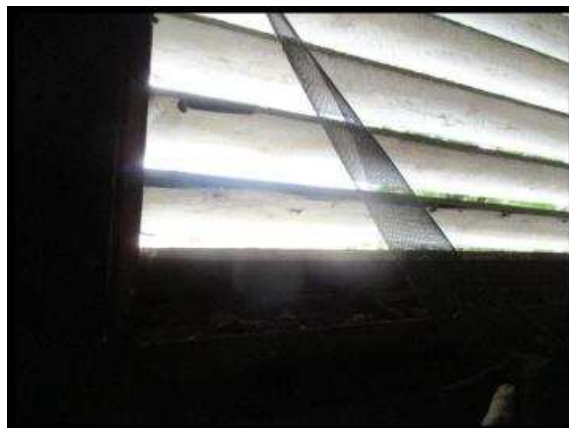
The decking was made of butted boards
The front gable vent screen was torn / damaged.

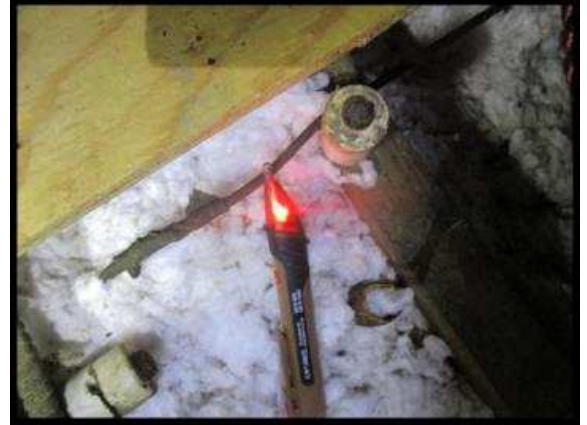
The house has existing knob and tube wiring in use. Due to the age of the wiring some insurance companies will no longer write policies on homes with knob & tube wiring.

It is recommended that you inquire with you insurance company to be sure they will insure the property. There was also BX cable, cloth braided romex, and some modern grounded copper romex noted.

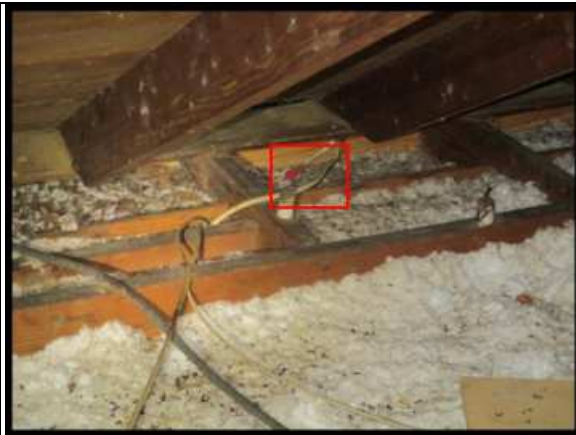
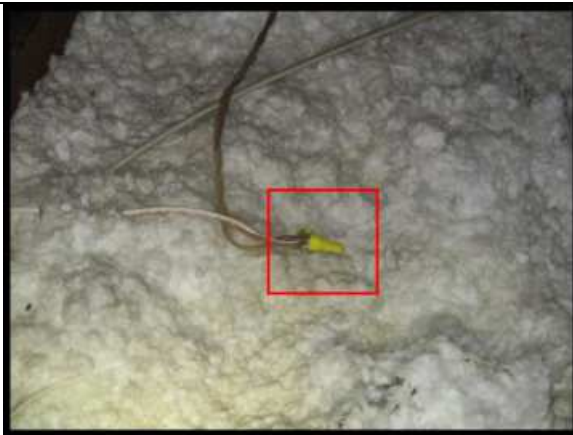
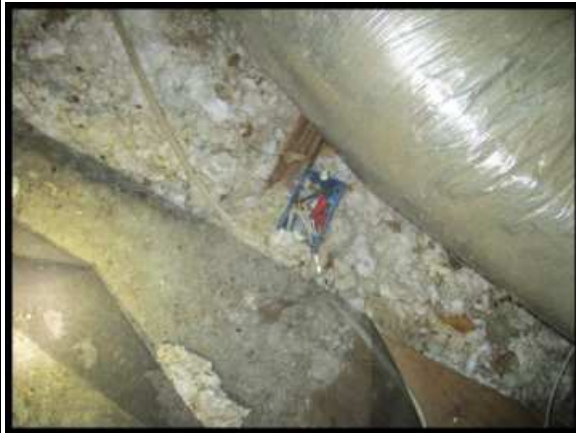
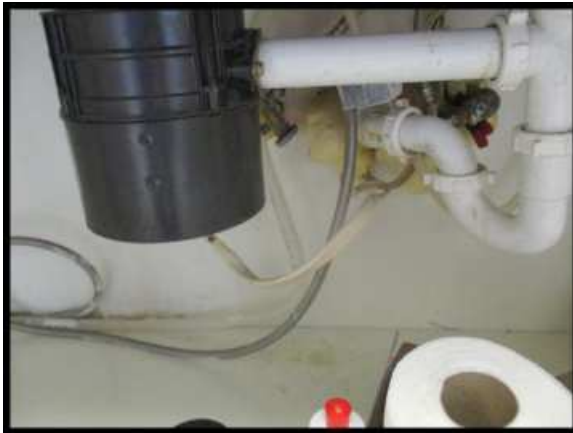
There was knob and tub wiring noted that was buried in insulation. There were wire terminations & splices noted not in covered junction boxes. There was a junction box noted with a missing cover. The wiring for the kitchen disposal was not in conduit. Examples pictured.

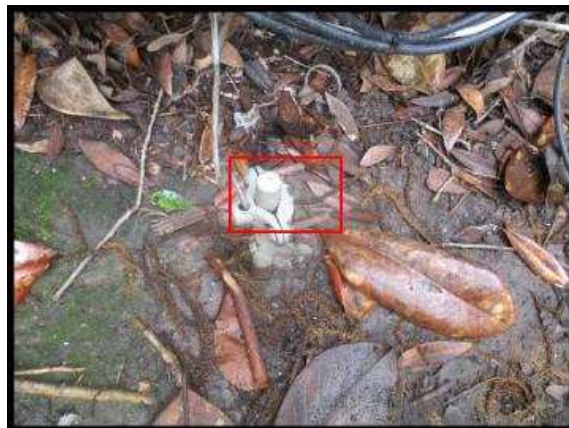
The ground driven rod, solid conductor, and connection were located. **The clamp that attaches the ground wire to the ground rod was loose. It is located below the electrical meter.**

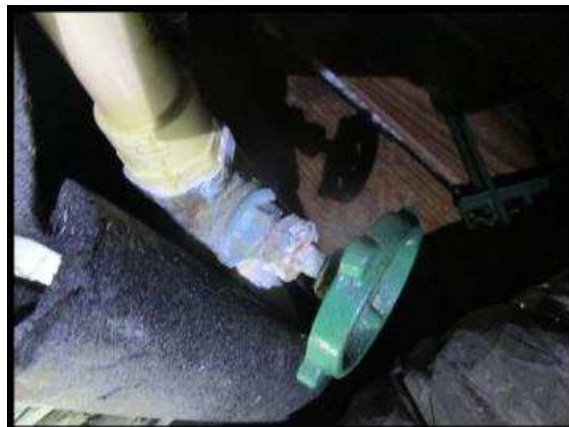
WATER HEATER FILL VALVE INSTALLED There was incrustation and/or mineral deposits from a past leak on the water shut off valve. However, no leaks are visible. Small leaks such as this often seal themselves due to corrosion. This area may leak again in the future. It is suggested that it be corrected.

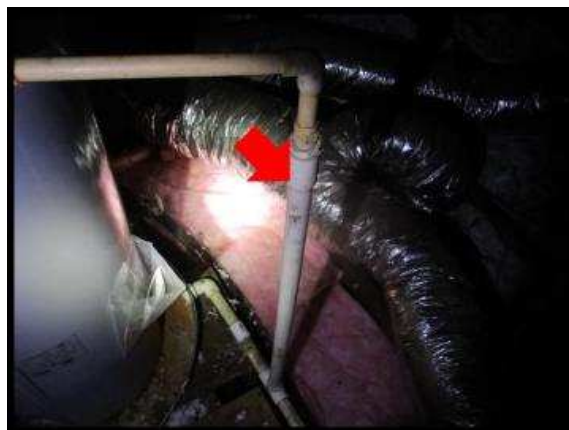
T&P DRAIN PIPE The T&P valve drain line was connected in to the PVC pan drain line.

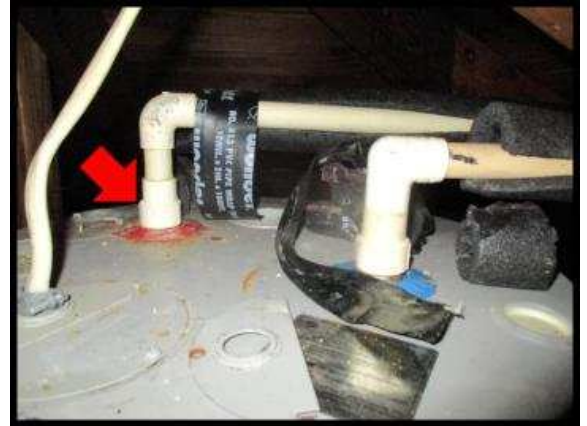
There was PVC piping / fittings noted carrying hot water. Example pictured. **Piping was noted in the crawlspace & exterior that was not insulated.** **PEX piping was noted in the crawlspace that was not secured / supported.**

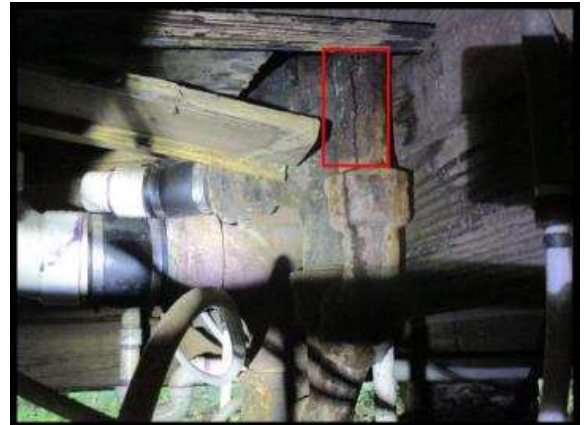
There was a waste piping leak noted under bathroom #1. Example pictured.

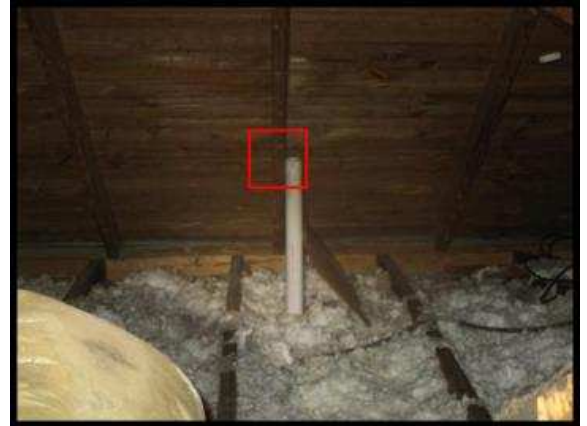
There was a PVC vent pipe noted that terminated in the rear attic area.

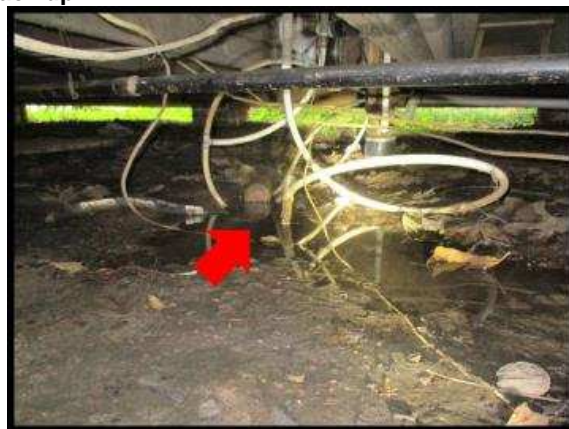
There was a pool of water noted in the crawlspace around an area of supply piping and water piping. The water was moving within itself. It is possible the water could be from a supply / waste pipe leak.

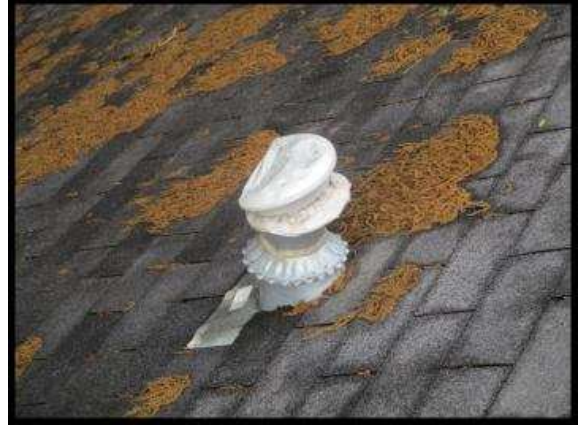
HEATING SYSTEM TYPE A forced air furnace was installed as the primary source of heat.
FUEL SOURCE The fuel source was natural gas.
FLUE TYPE The flue pipe was metal.
FLUE CONDITION **The heating unit flue cap was crushed / damaged.**

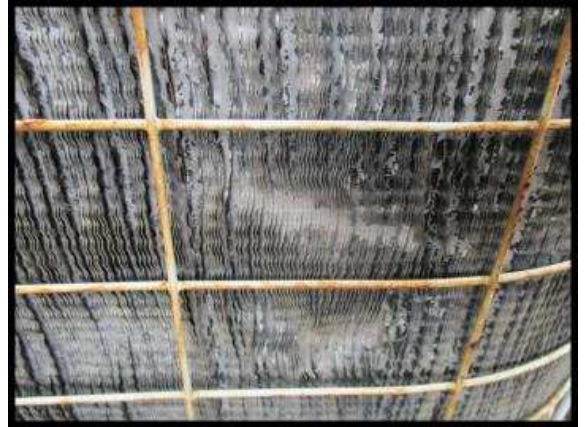
CONDENSING COIL CONDITION The condensing coil has several damaged / crushed fins.

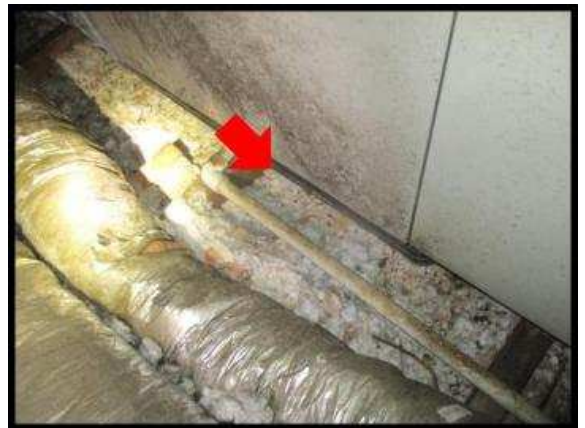
SECONDARY DRAIN PAN CONDITION **The drain pan was not properly centered under the evaporator.**

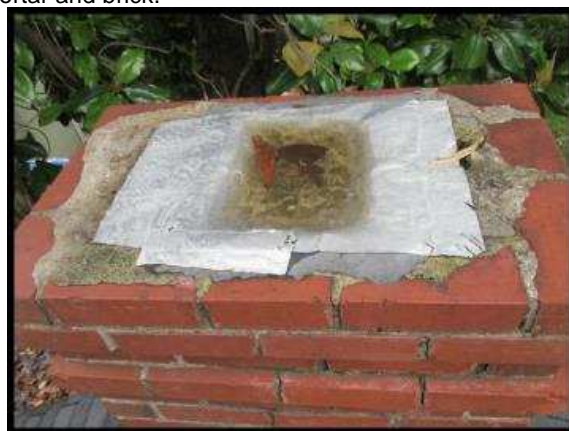
The exterior stack appeared to be in satisfactory condition. **The flue was capped at the top it what appeared to be foil tape. Installation of a metal sap is recommended.**

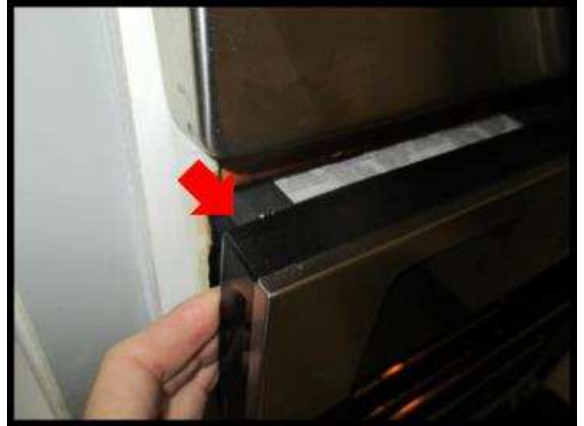
All the range top burners were tested and were functional. The oven also was functional. Temperatures of heat settings were not tested. **The oven was not secured in the cabinet.**

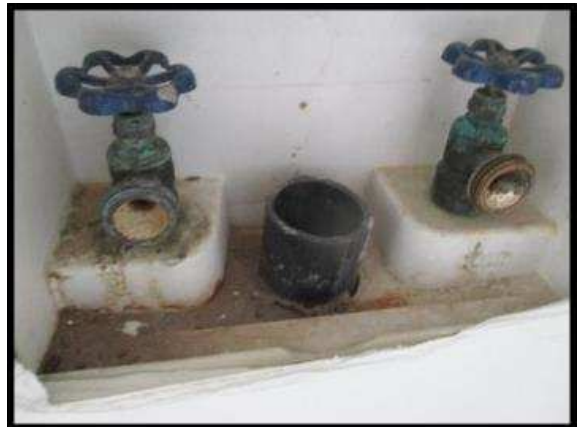
There was a connection box installed in the wall supply connections and a drain pipe. The drain pipe and connections were not tested. **There was incrustation and/or mineral deposits from a past leak on the water shut off valves for the washing machine.** No leaks were visible. Small leaks such as this often seal themselves due to corrosion. This area may leak again in the future. It is suggested that it be corrected.

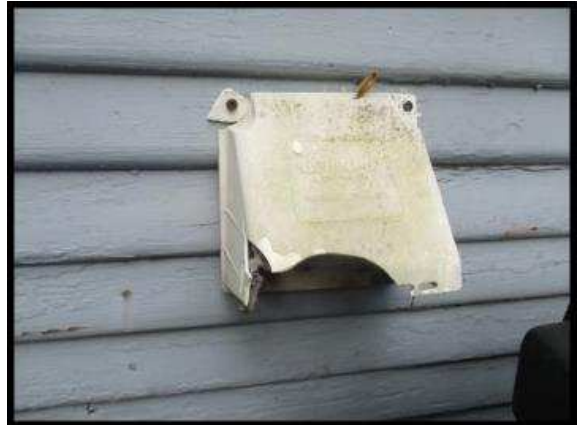
The dryer vent was damaged at the exterior.
